### STAFF REPORT ITEM NO. B.

ADDRESS: 1005 McMath Ave.

COA REQUEST: Infill House

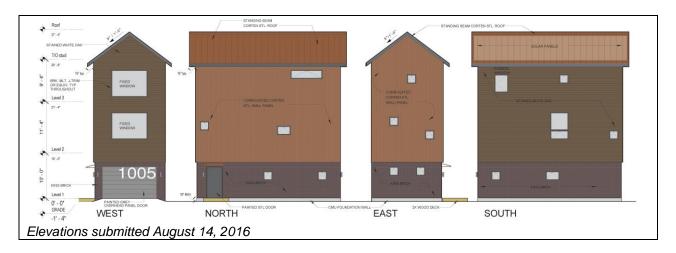
**GENERAL DESIGN**. It is a three story single family residence with a gable end roof. The front façade (west) is dominated by a garage door on the first floor and a large fixed window on the second and third floor. Windows on the other three facades are scattered with various sizes and shapes. The first floor is masonry; king size brick. The remainder of the front façade and the south facades are stained white oak laid horizontally. The remainders of the north and east facades are proposed to be corrugated CorTen steel wall panels. CorTen steel has a naturally oxidizing finish. Weathering steel is a group of steel alloys developed to obviate the need for painting and form a stable rust-like appearance if exposed to the weather for several years. The south facing slope of the roof is proposed to have solar panels. The roof is proposed to have standing seam CorTen steel panels.

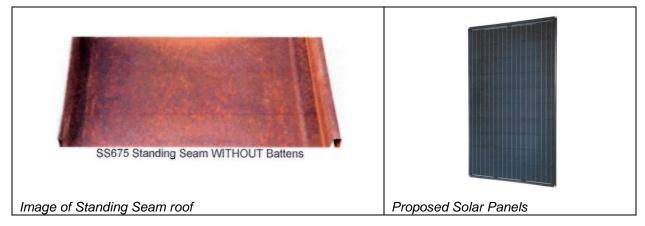
ROOF AREA. The house features a gable roof with a 9/12 pitch. The roof will be CorTen #ss675 standing seam roof, 16" wide and 22 gauge metal. There will be a fixed vented ridgecap 7" on each slope. Some historic houses originally had metal roofs, some standing seam and some metal shingles. The CorTen steel roof will be a matte finish as the steel rusts and produces a medium to dark brown color. The roof shape and material is appropriate to the district.

The solar panels are to be located on the south side of roof. They are made by Sunmodule Plus SW280 Mondo Black. They are 8 kilowatt each and measure 66"x37" each. The proposal is to place 20 panels on the south facing slope of the roof for an area of 30'x12'. The location is for maximum efficiency, but they will be visible from the street.

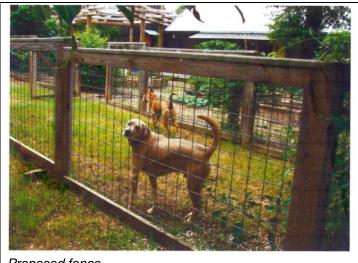
Proposed fence

Fencing is to be pine wood and 4"x4" utility wire, picture framed with pine and attached with galvalume screws.

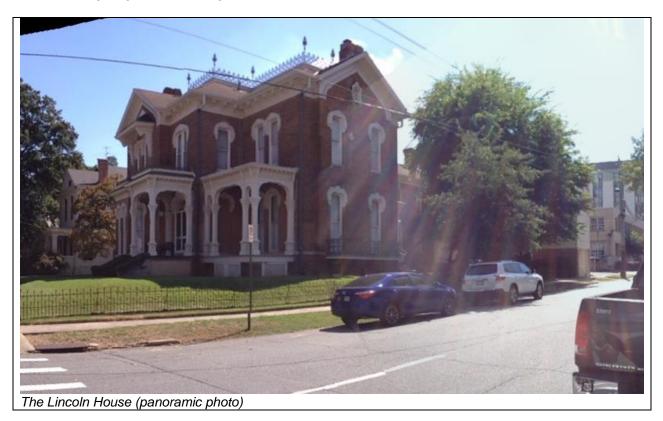
The Lincoln House, an Italianate structure is shown above with the front façade facing 7th Street and the detached garage facing Cumberland Street. The detached garage is to the left in the photo behind the tree.

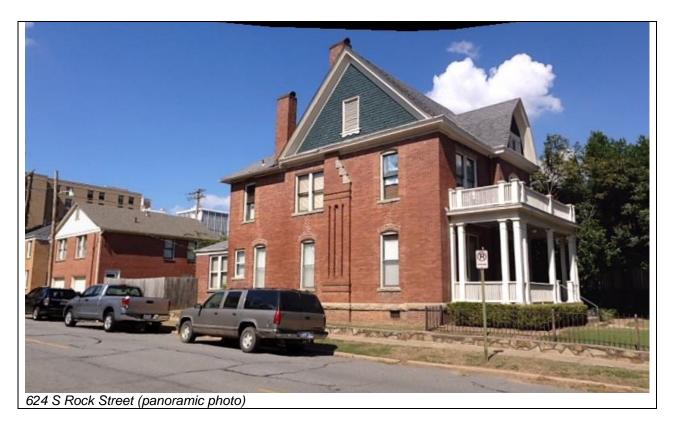
624 S Rock is shown above with the front façade facing Rock Street and the detached garage facing 7th Street. The detached garage is to the right in the photo.

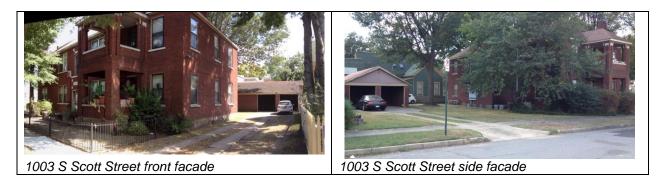
The Bragg Apartments at 1003 S Scott is shown above. This building from is unique in the fact that the detached garage is located at the far back corner of the lot with the garage accessible from both street and two garage doors on two façades. This does fit the pattern in the facade that the garage is smaller in footprint area, smaller in mass and is located on a corner lot.
